MEMORANDUM

TO:	Brandon Laurie Pakpour Consulting Group	Date: June 23, 2016 Time: 9:30 am Weather: Sunny & Cool
FROM:	Thomas L. Swayze, SE	Job No: 2016022
PROJECT:	Tournament Tank No. 1 Water Tank Structural Observation of Tank

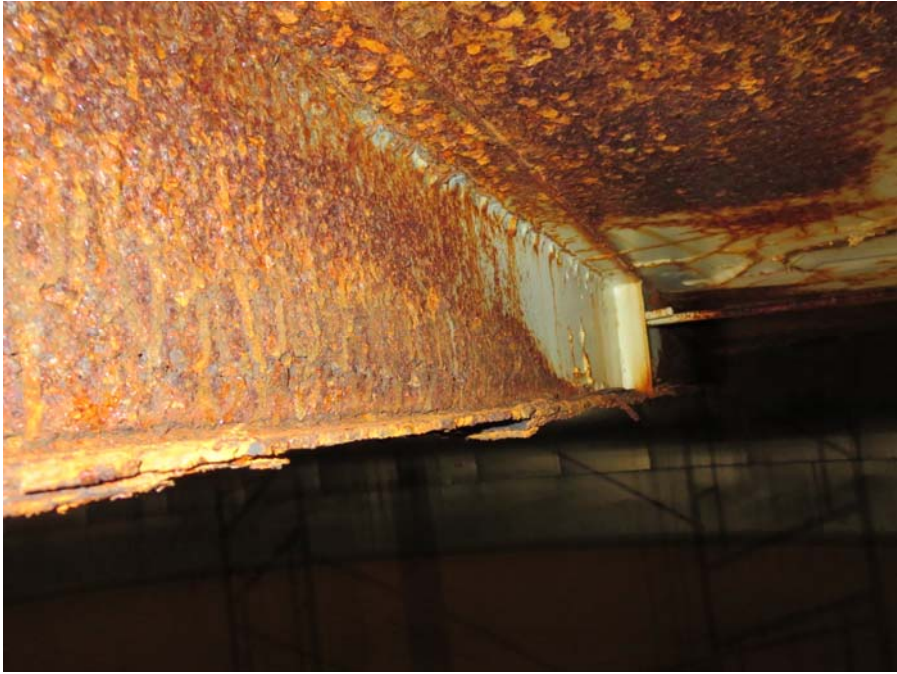
1. Scaffolding was installed which allowed for us to observe the roof rafters, roof plate, and dollar plate from up close to better assess the damage due to corrosion. Approximately 30-40% of the rafter bottom flanges were observed to have significant corrosion, mostly on the eastern half of the tank. Of those rafters, approximately 4-5 rafters were observed to also have corrosion on the top flange. In some locations, significant section loss has occurred and flanges were observed to flake off by hand due to the corrosion. The dollar plate was observed to be in fairly good condition as observed. It appears not to have lost much of its section. Some corrosion is evident throughout the dollar plate. Rust stalactites were observed on the underside of some of the roof rafters in several locations. Knuckle plates were observed to have some minor rusting, but in good condition overall.

Figure 1: Bottom Flange Corrosion and Section Loss in Rafter

Rafter flange repairs will be necessary in various locations in which significant section loss was observed. More precise determination can be made subsequent to cleaning. Rafters and roof should be cleaned and painted as a maintenance item to extend the life of tanks.

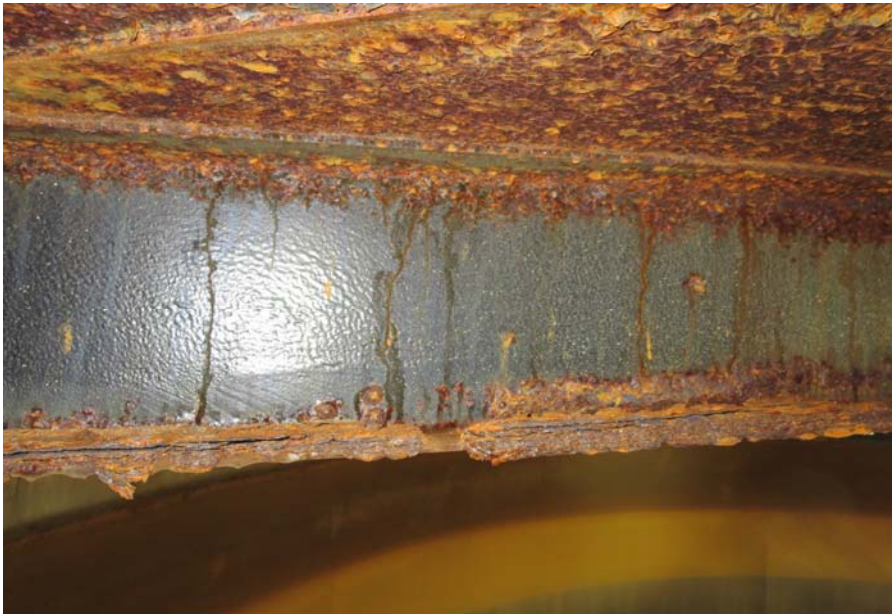
Figure 2: Bottom Flange Corrosion and Section Loss in Rafter

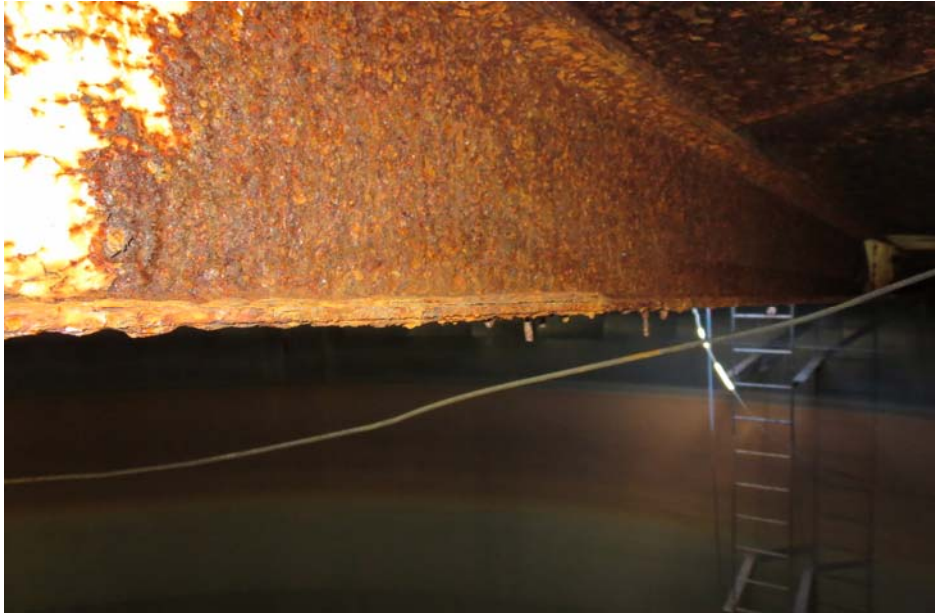
Figure 3: Top Flange Corrosion

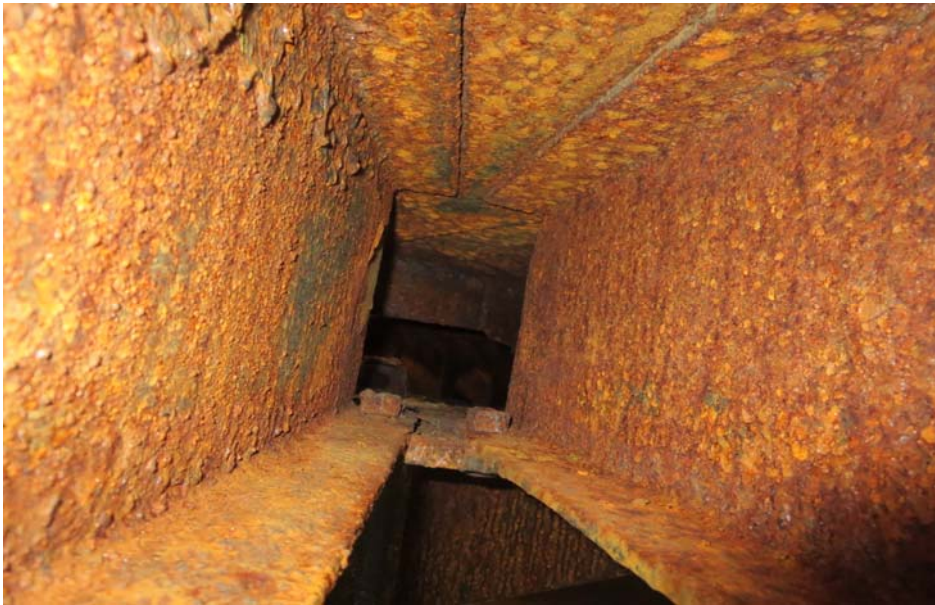
Figure 4: Dollar Plate Corrosion

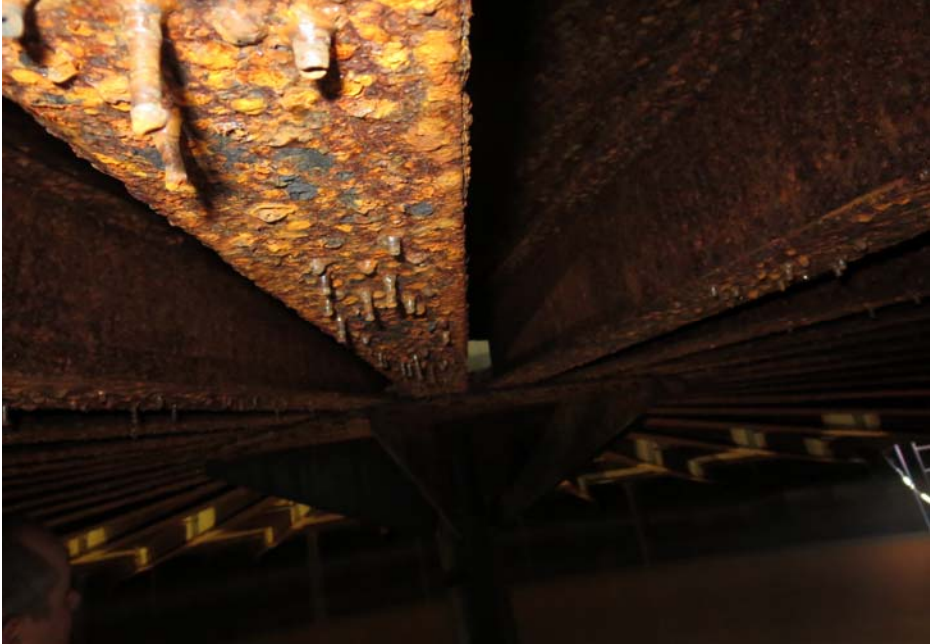
Figure 3: Stalactites Developing on Bottom Flange of Rafter
