MEMORANDUM

TO:	Brandon Laurie Pakpour Consulting Group	Date: May 17, 2016 Time: 10:00 am Weather: Sunny & Cool
FROM:	Chris Ingle, PE Thomas L. Swayze, SE	Job No: 2016022
PROJECT:	Tournament Tank No. 2 Water Tank Structural Observation of Tank

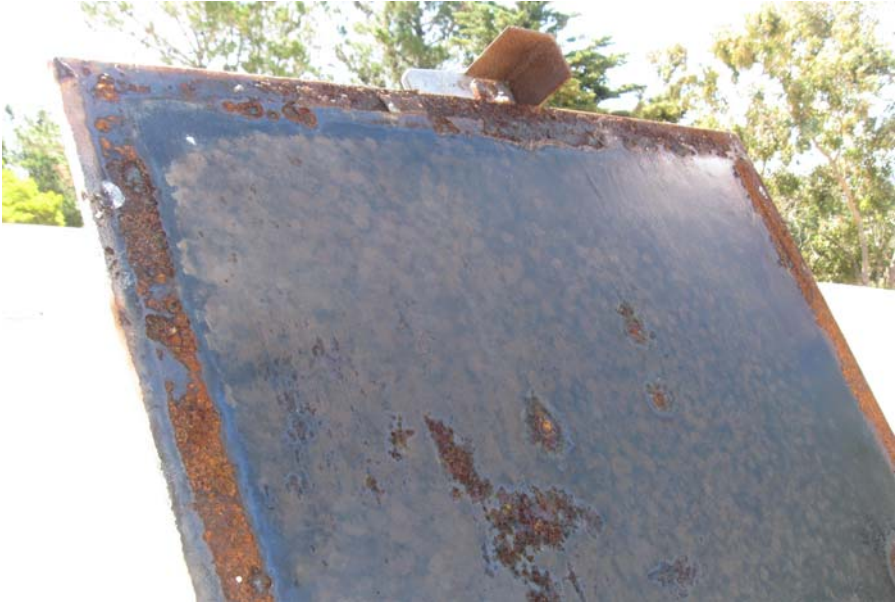
Figure 2: Underside of Roof Hatch

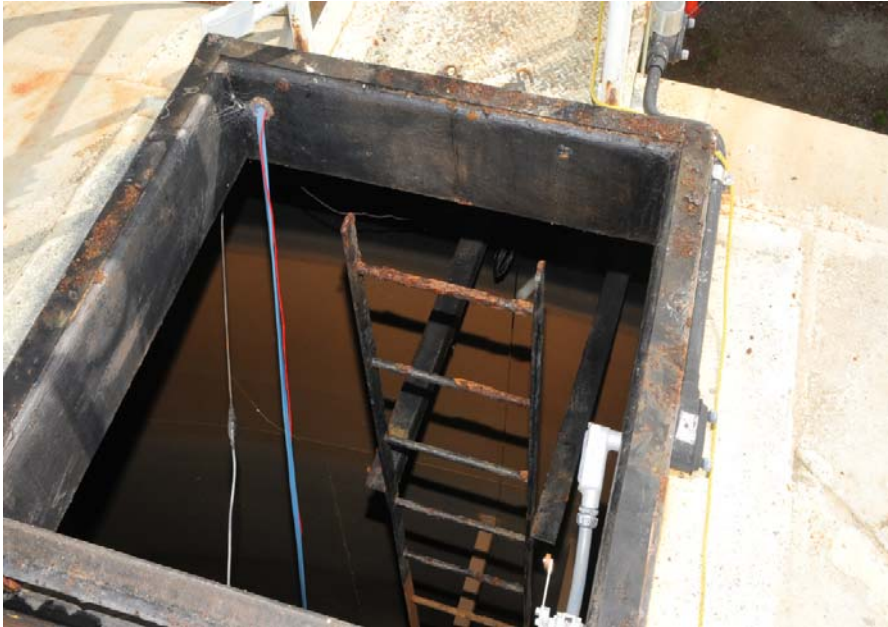
1. Access was permitted to the inside of the tank through one of the man hatches. From the floor, we observed some corrosion on the underside of the rafters, the underside of the roof plate, the dollar plate, and the ladder on the inside of the tank. Rafters adjacent to ladder were visible and corrosion did not seem to be serious. In general the corrosion appeared minor; however the extent of corrosion could not be properly assessed without a close inspection subsequent to cleaning from scaffolding, which is scheduled for a later date.
2. Access was permitted to the roof of the tank by use of the ladder on the outside of the tank. The tank hatch was observed and appeared to be in good condition with minor rust developing around its perimeter and underneath the lid. The roof plate was observed to have patches of minor rust throughout.

Figure 3: Rusted Ladder on Interior of the Tank

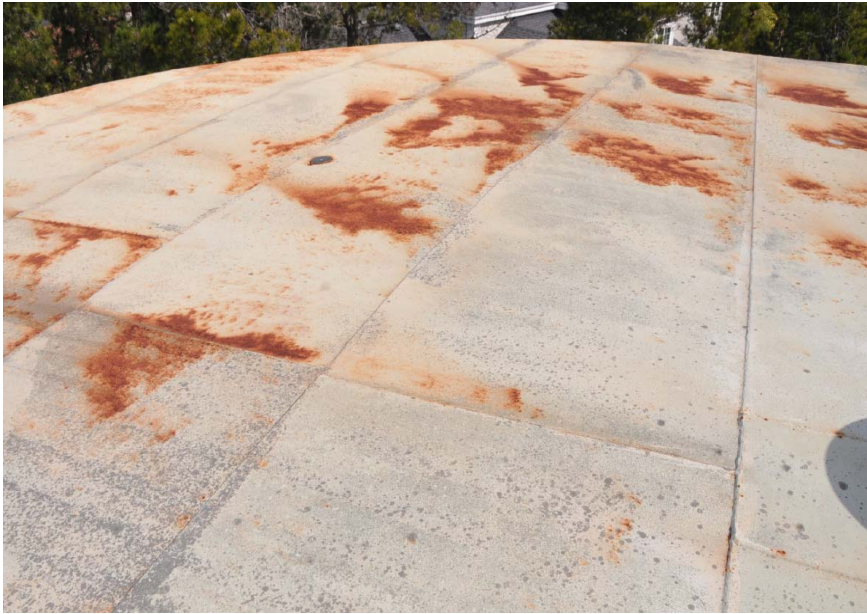
Figure 4: Patches of Rust on the Roof Plate

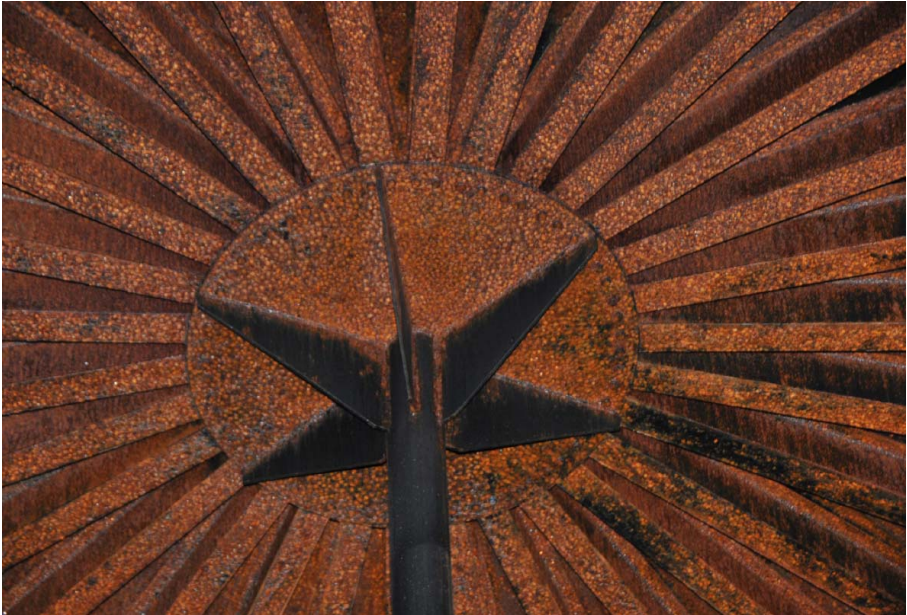
Figure 5: Corrosion on underside of Dollar Plate

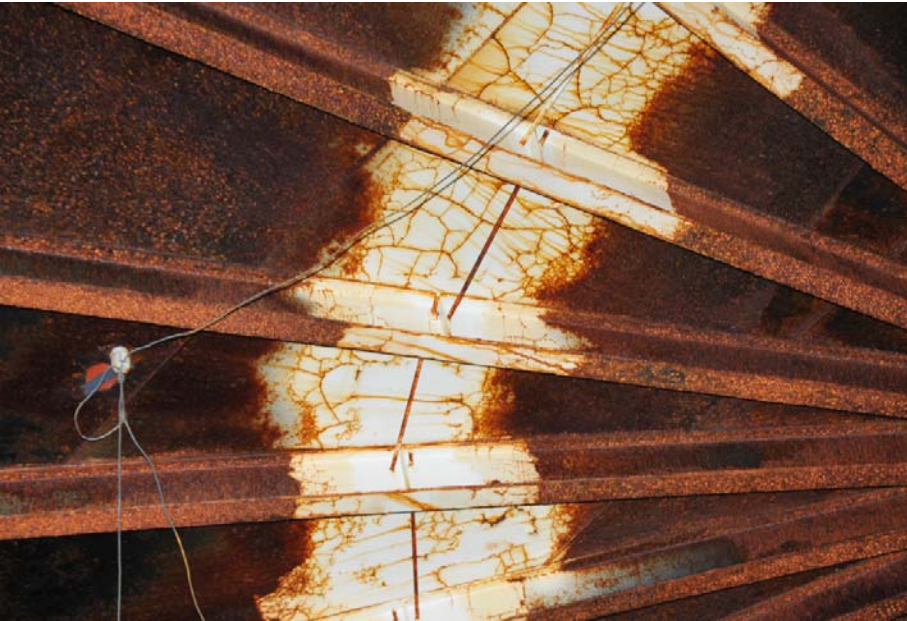
Figure 6: Corrosion on underside of Rafters and Roof Plate

It should be noted the tank is scheduled to be cleaned prior to further observation of the extents of corrosion damage. Also, scaffolding will be installed on the inside of the tank at a later date to further assess corrosion damage to the roof plate and rafters.

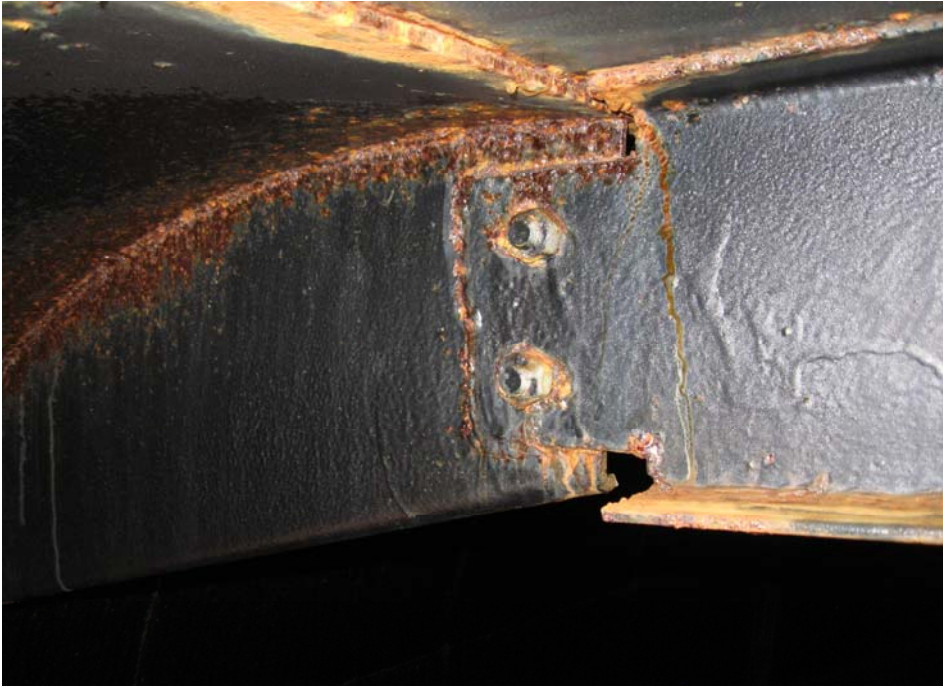
Figure 7: Corrosion on Knuckle Plate
