MEMORANDUM

TO:	Brandon Laurie Pakpour Consulting Group	Date: June 15, 2016 Time: 10:30 am Weather: Sunny & Cool
FROM:	Thomas L. Swayze, SE	Job No: 2016022
PROJECT:	Tournament Tank No. 1 Water Tank Structural Observation of Tank

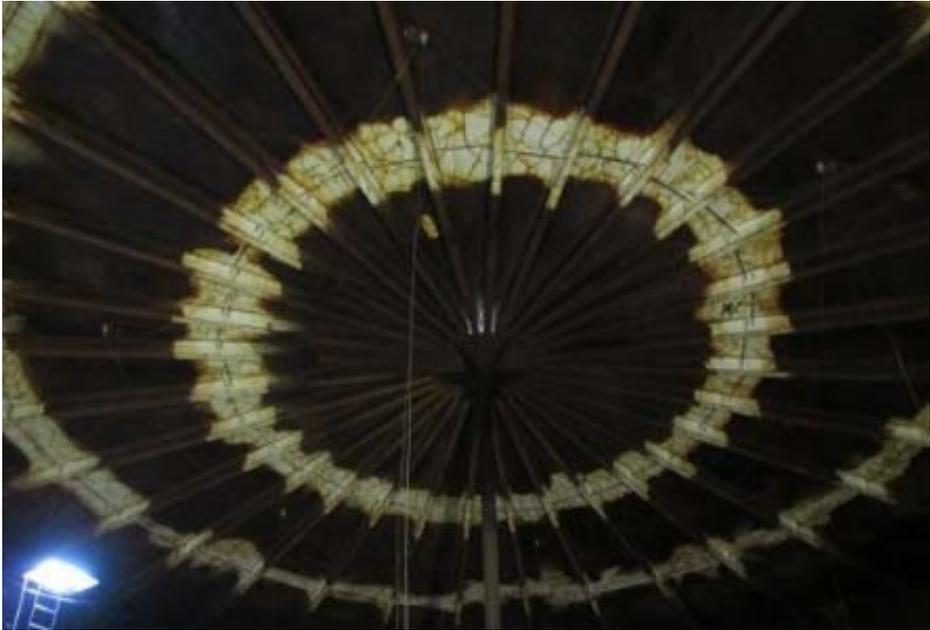
1. Access was permitted to the inside of the tank through one of the man doors. Similar to Tournament Tank No. 2, we observed some corrosion on the underside of the rafters, the underside of the roof plate, the dollar plate, and the ladder on the inside of the tank. Beam flanges flaked off by hand in various location due to the severe corrosion on the beam flanges, where some of the bottom flanges appear to be delaminating. The corrosion appeared to be more severe than Tank No. 2, however the extent of corrosion could not be properly assessed without cleaning and observation from scaffolding, which is scheduled for next week.

Figure 1: Corrosion on Underside of Roof

It should be noted that scaffolding will be installed on the inside of the tank next week, allowing us to further assess corrosion damage to the roof plate and rafters.

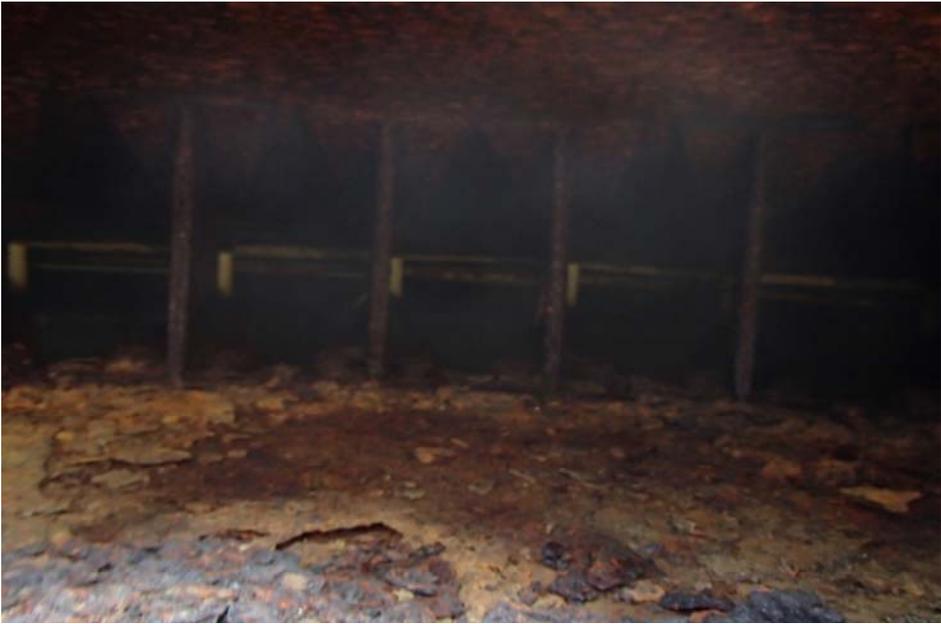
Figure 2: Roof Rafter at Dollar Plate from Center Vent

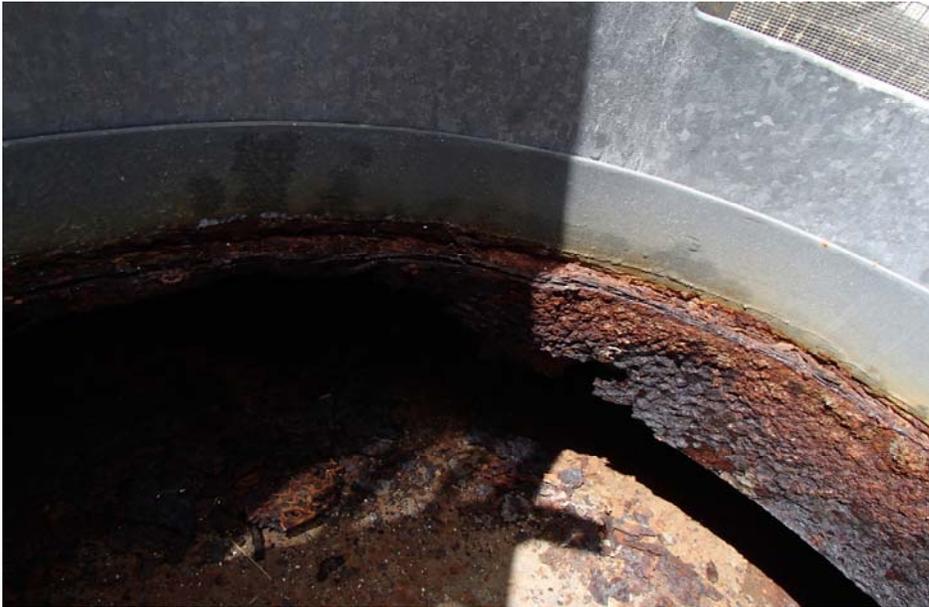
2. Access was permitted to the roof of the tank by use of the ladder on the outside of the tank. The tank hatch was observed and appeared to be in poor condition with rust developing around its perimeter and underneath the lid. The roof plate was observed to have patches of minor rust throughout its area. The center vent hood was removed for observation of the condition of the dollar plate, which showed signs of minor corrosion but appeared to be in fair condition without significant section loss. The collar around the vent exhibited significant section loss and should be replaced in kind. Girder ends did appear to be corroded somewhat but could be cleaned up prior to painting.

Figure 3: Section Loss in Center Vent Collar

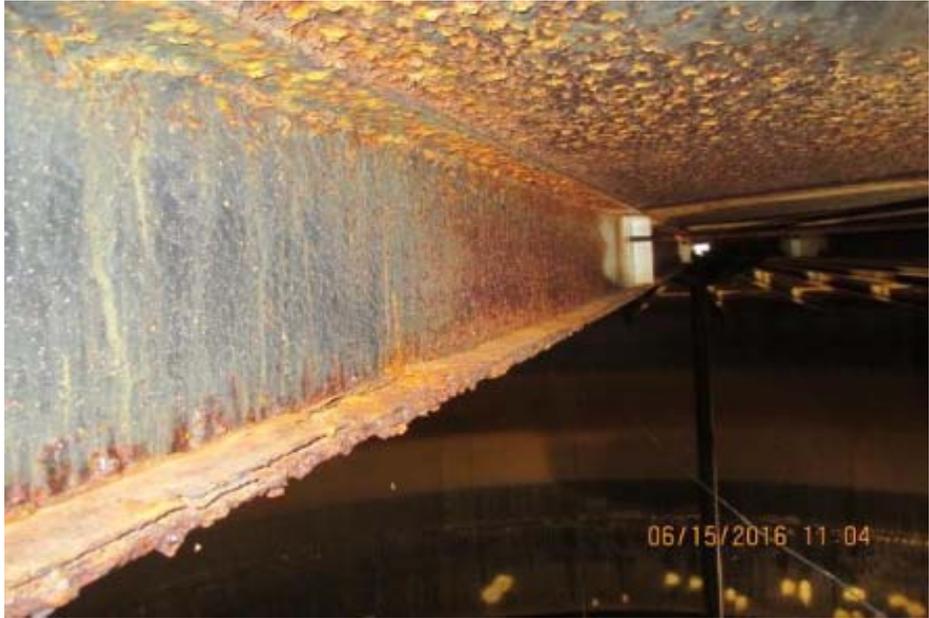
Figure 4: Corrosion of Roof Rafter Flange

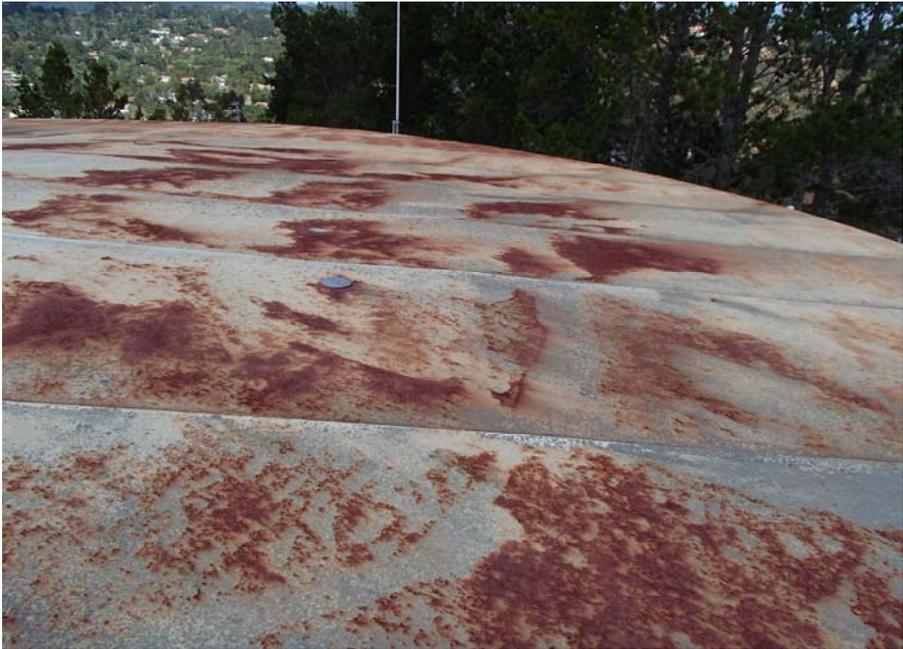
Figure 4: Patches of Rust on the Roof Plate
