**PRELIMINARY LIMNOLOGICAL SURVEY OF  
CROCKER LAKE RESERVOIR, HILLSBOROUGH, CALIFORNIA  
WITH RECOMMENDATIONS FOR  
FUTURE LAKE PLANNING & MANAGEMENT**

**Alex Horne, Ph. D**  
**Alex Horne Associates**

5 February 2006

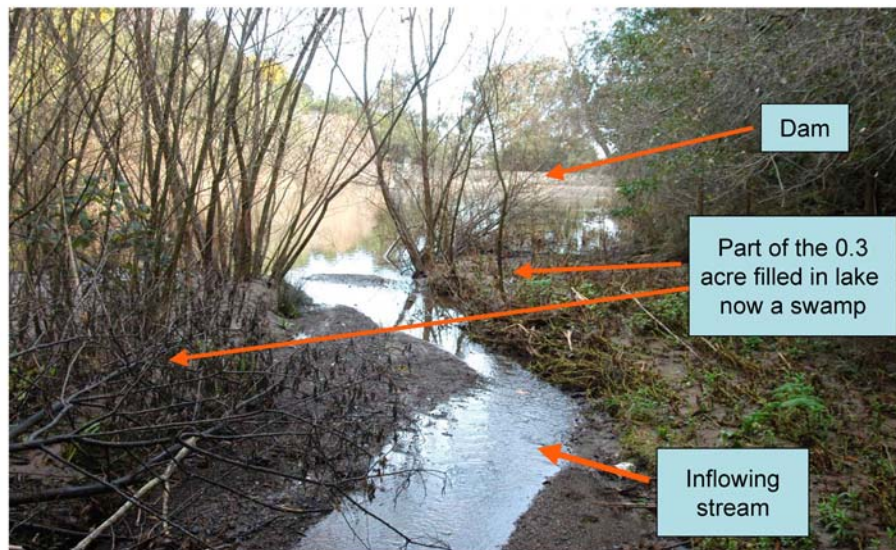
- The upper end of the reservoir is a flat swamp with willows and cattails at the downstream end (Fig. 3). Just upstream of the reservoir, the area that is bounded by a berm is also now flat and a swamp. This berm appears to have been constructed to catch sediment before it reaches the reservoir, but the area is now full and no longer working as a catch basin. Both sites have filled in due to sediment deposition since the natural canyon is steep and V-shaped.

Fig. 3. Lost upper section of the Crocker Lake Reservoir due to severe sedimentation – now a willow swamp

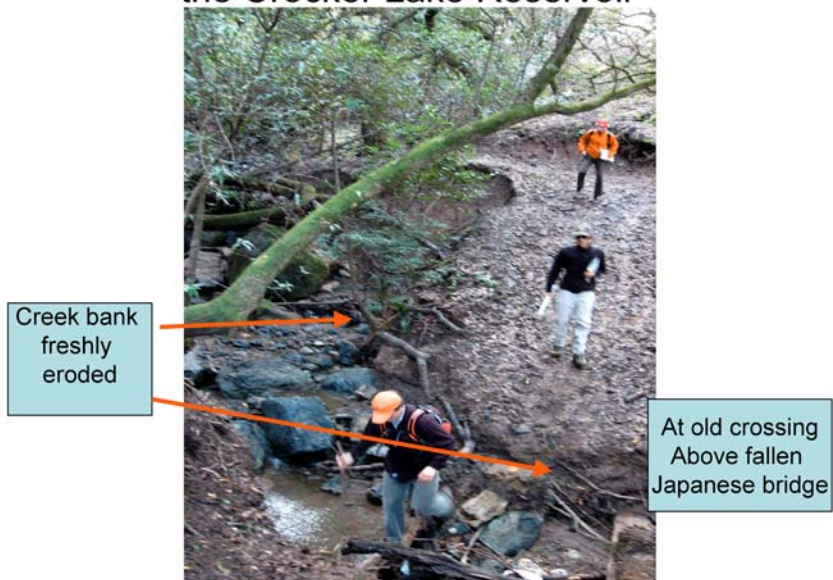
- During our visit there were large areas of at least two sections of the small inflowing creeks that had freshly eroded. In one example on the main creek just upstream of the fallen “Japanese Bridge” the old track over had completely washed out (Fig. 4). Whole banks of sediment had slumped and been washed downstream. In a smaller upper creek the drainage pipe from the road was sticking out about 8 feet indicating its original supporting soil had washed out. The entire canyon is very steep, and the high rains, compounded by runoff from impervious roads and homes, can easily wash away the soft soil. Smaller erosion examples were common along the graded tracks, especially below storm drainage pipes from homes and streets that ring the canyon. A large example of mass wasting from some years before was evidenced by a large, recently cleared and graded area. The reservoir is the first site along the creeks where sediment can settle so any sediment now in the creek will end up in the lake.

Fig.4 Severe erosion in main creek upstream of the Crocker Lake Reservoir

1. Initiate controls on sediment entering the reservoir. Begin plans to control erosion in the watershed using check dams &/or retention basins &/or wetlands filtration basins. Since the water supply of the Burlingame Country Club is involved, they should be brought into the negotiations since it is in their medium-term interests to support dredging. (Their water store will cease in 10-20 years when the reservoir silts in completely.)
2. Choose a dredging option(s) and initiate funding search. Federal-State grants require some kind of public access to the lake.
3. Prepare for a summer limnological survey (especially oxygen & nutrients).
4. Determine who controls the water level in the dry season.
